MEMORANDUM

Project: Gold King Interim Water Treatment Plant (IWTP)

Reporting Period: Oct 10 – Oct 17

Report No.: 40

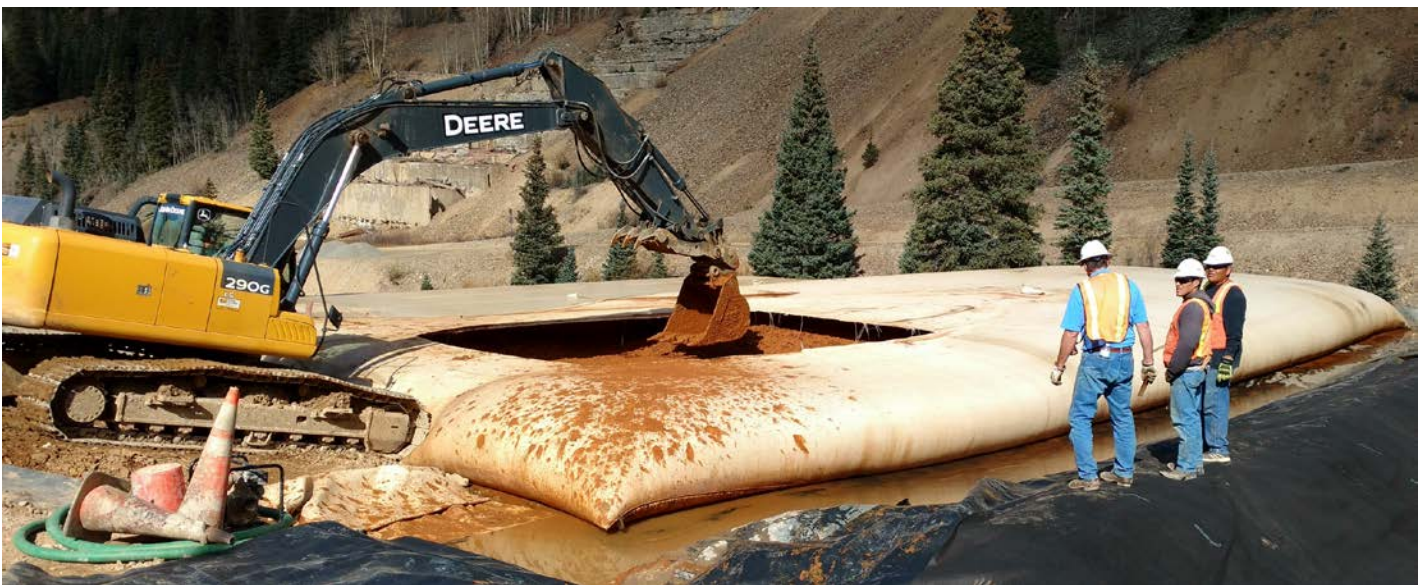
Photo 1: Removal of sludge from Cell B.

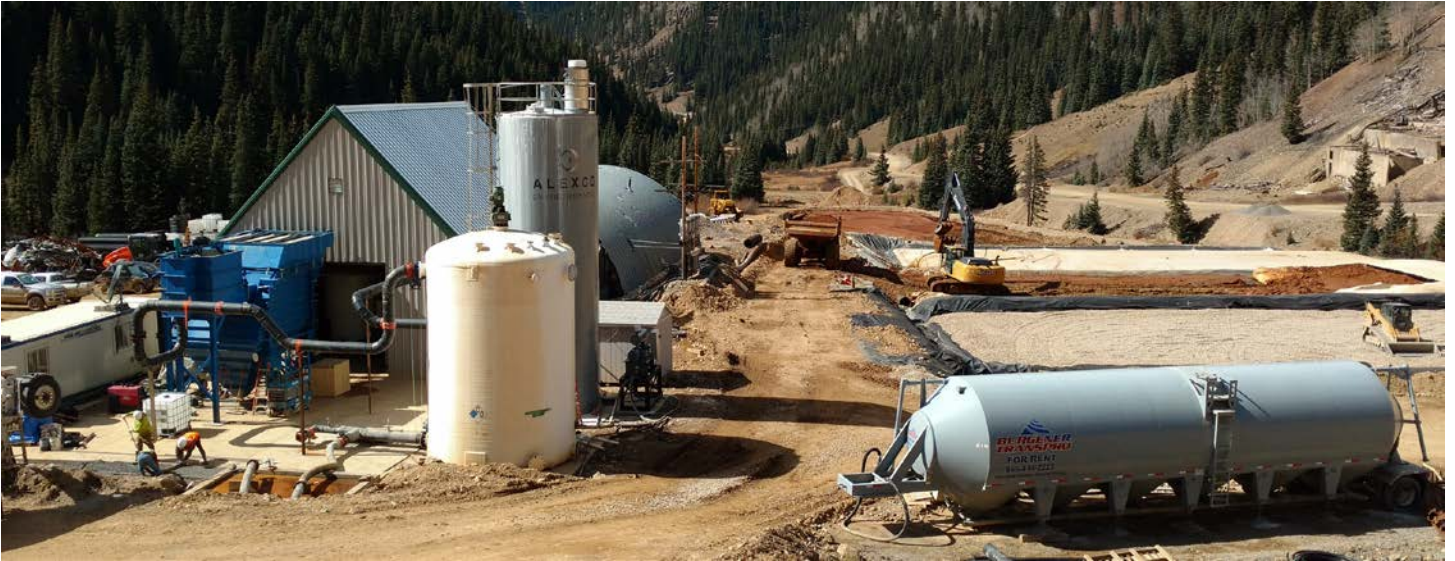
Photo 2: Pour of concrete extension, rock placement in Cell A, and removal of sludge from Cell B.

- Alexco/Summit Mechanical reconnected the Reactor Tank to the Phase II clarifier and rerouted the 3" sludge line to the bags.
- Alexco/StoneTree poured an 8" thick concrete extension to the existing pad, as well as sill around the existing IWTP building to keep water from infiltrating underneath the walls.
- ER removed the sludge and bag from Cell B.
- Lange Containment relined Cell A. ER installed 2" round river rock within Cell A, 10" thick.
- Rapid Energy reconnected the 50hp blower, and will procure all materials for heat trace, pump starters, and outlets at each cell.
